**Reinforced anti-crack complex for protection of fatigued pavements:
feedback from a new preservation solution**

COLAS

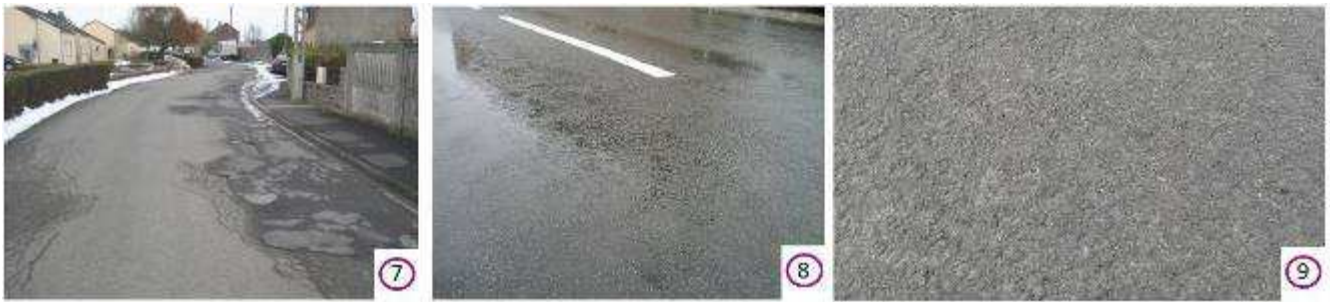
Figure 3: Impermeability of the road structure

Water is one of the main threats to pavements: through seepage, it degrades the performance of the road structure. It reduces the bearing capacity of the subgrade. In winter, as a result of frost, water can degrade the materials in the pavement, which then undergoes a long deterioration process (Fig.3/Photo 7).

Visual inspection reveals that the structure no longer absorbs stormwater (Fig.3 /Photo 8), skidding resistance is maintained as the result of a mean texture depth (MTD) that is equivalent to that measured in a semi-course asphalt concrete with a mean macrotexture depth of over 0.6 mm (Fig.3/Photo 9).

Photo 7: Structure damaged by frost and road traffic

Photo 8: Surface state of the composite road surfacing after a period of rainfall: the water does not seep into the structure

Photo 9: Surface roughness of the composite road surfacing equivalent to a 0/10 semi-coarse asphalt concrete.

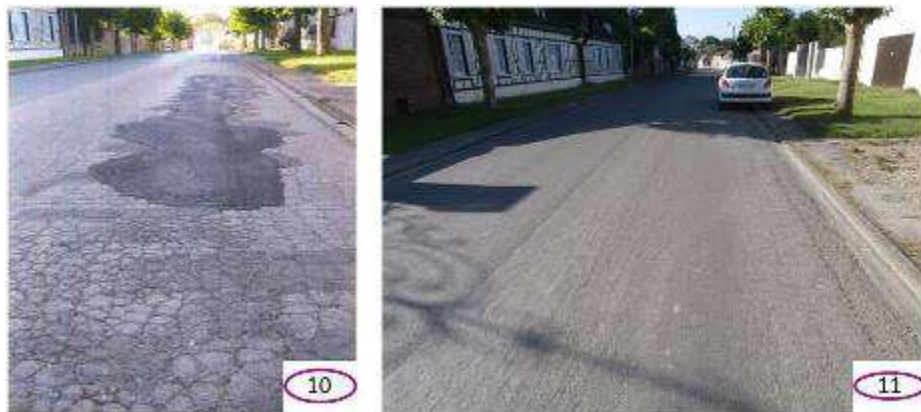
Figure 4: ARVILLERS: State of the pavement before the project and after 3 years of trafficking

This is one of the first projects carried out in 2011, the road through Arvillers, a municipality located in the Picardy region. Figure 4 shows the changes in the road structure after three years of use under T3 traffic (50 trucks/day to 150 trucks/day). The structure has retained its integrity in spite of its very poor initial state.

Photo 10: Damaged structure before laying of the fiber-filled composite road surfacing

Photo 11: Surface state of the composite road surfacing after 3 years. The structure has retained its integrity.

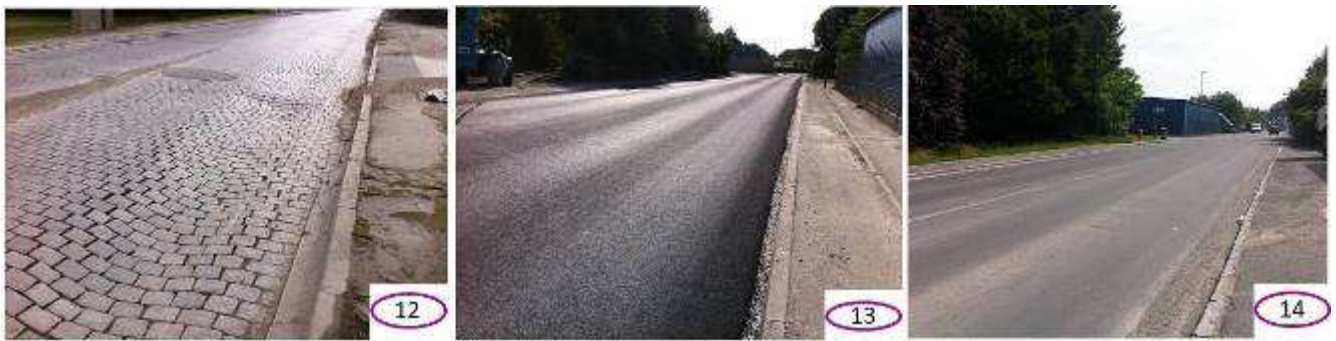
Figure 5: Port of LILLE: State of the pavement after 1 year of traffic

The existing structure showed significant deformations (old cobbled pavement Fig 5 /Photo 12) and was no longer able to carry truck traffic. An emergency decision was taken to evaluate the new fiber-filled composite road surfacing (Fig 5 /Photo 13) after taking the precautionary measure of reprofiling the entire structure with bituminous products in order to restore not only the longitudinal profile but - in particular - the transverse profile.

The structure's performance after one year with this surfacing (Fig 5 /Photo 14) was quite satisfactory, and a recent inspection carried out in June 2019, i.e. six years after construction, showed its effectiveness. In spite of the need for some localized repairs the product has withstood stresses better than expected.

Photo 12: State of the structure prior to works

Photo 13: Pavement surfaced with fiber-filled composite road surfacing after reshaping works

Photo 14: State of the structure after 1 year of trafficking

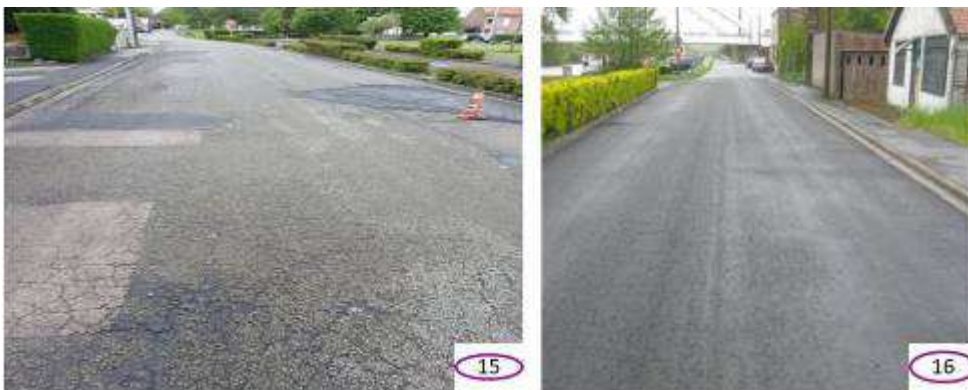
Figure 6: Béthune: Rue Conflans St Honorine. State of the pavement after 1 year of traffic

Analysis of the measurements showed a significant improvement in the deflection level in the first 6 months, with an initial characteristic deflection level of 234/100 mm. After the works, the deflection level remained at 150/100 mm over the three years of testing, i.e. a reduction of about 36% compared to the initial characteristic deflection.

Because the impermeability of the pavement has been maintained, the structural layers of the pavement have been rehabilitated with a reduction in the hydric state of the road foundation; the moduli of the materials have actually improved and improved the structure's performance.

Photo 15: State of the structure prior to works

Photo 16: Pavement surfaced with fiber-filled composite road surfacing after 1 year

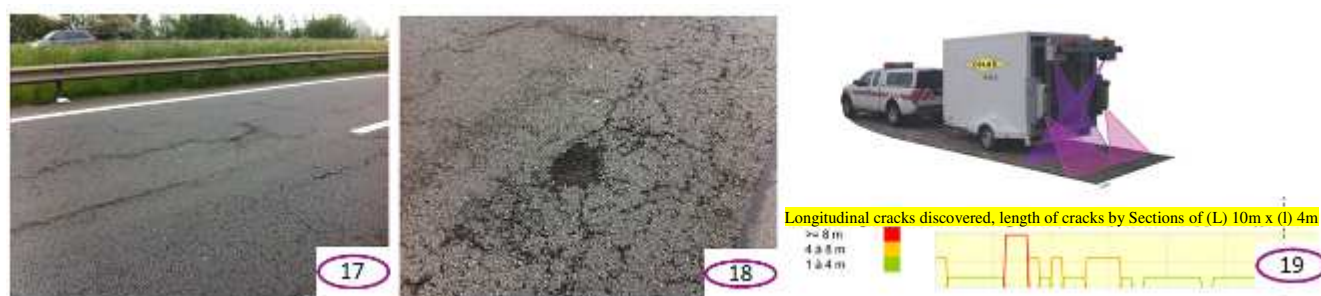
Figure 8: A23 motorway: Damage survey

The A23 consists of a semi-rigid structure made from treated base gravel surfaced by a severely damaged 0/14 high modulus asphalt concrete (Fig.8/Photo 17-Photo 18). It should be explained that when the wearing course was laid it was very common practice to use hard multigrade bitumen.

Photo 17 - Photo 18: State of the surfacing prior to works

The appearance of the surface was extremely varied with old zones exhibiting crazing and zones where the wearing courses has been partly replaced, and a large number of cracks (both thermal and fatigue), particularly in the outer lane.

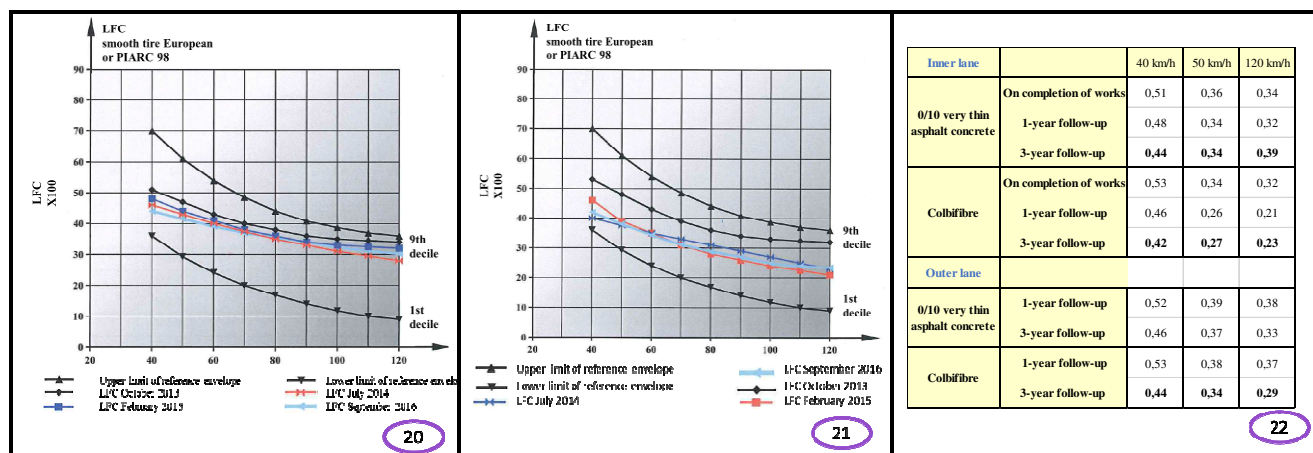
Figure 9: LFC measurements

For the Very Thin Asphalt Concrete, on the inner lane, a reduction in the LFC at 40 km/h was observed between the values after 1 and 3 years, which did not apply in the case of the fiber-filled composite road surfacing, for which the values were fairly similar at all traffic speeds.

In the outer lane, the LFC measurements on the Very Thin Asphalt Concrete and the composite road surfacing were similar.

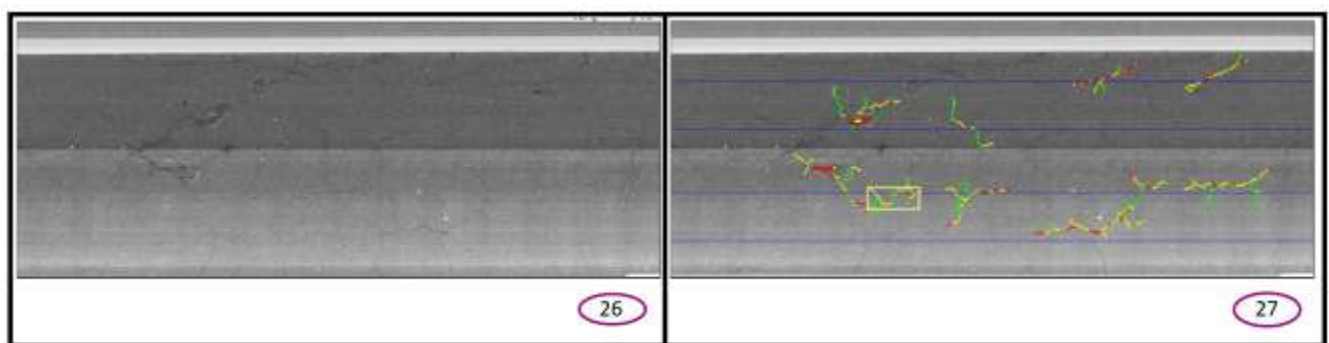
Figure 12: Survey of damage prior to works

The Road Eagle enabled us to monitor changes in the state of the surface in the course of three measurement campaigns. The first measure the initial state, the second the state two years after the works and the third the state five years after. This technique allowed us to observe a low level of rutting on the pavement prior to works, but a large amount of cracking and crazing. Figure 12 shows the state of the pavement before and after data processing. The presence of disorderly cracks is clearly apparent.

The third measurement campaign that was performed after five years showed that the Very Thin Asphalt Concrete strip exhibited a reappearance of cracking which was neither longitudinal nor transverse and whose total length was between 0.3 and 5m.

On the fiber-filled composite surface strip, no cracking was apparent after five years showing its very good ability to limit reflection cracking.
