**Percolated asphalt coating as an anti fuel solution in a heavy traffic motorway**

*<sup>1</sup>Eiffage Infraestructuras, <sup>2</sup>Universidad Alfonso X El Sabio, <sup>3</sup>AUTOPISTAS, <sup>4</sup>ACESA*

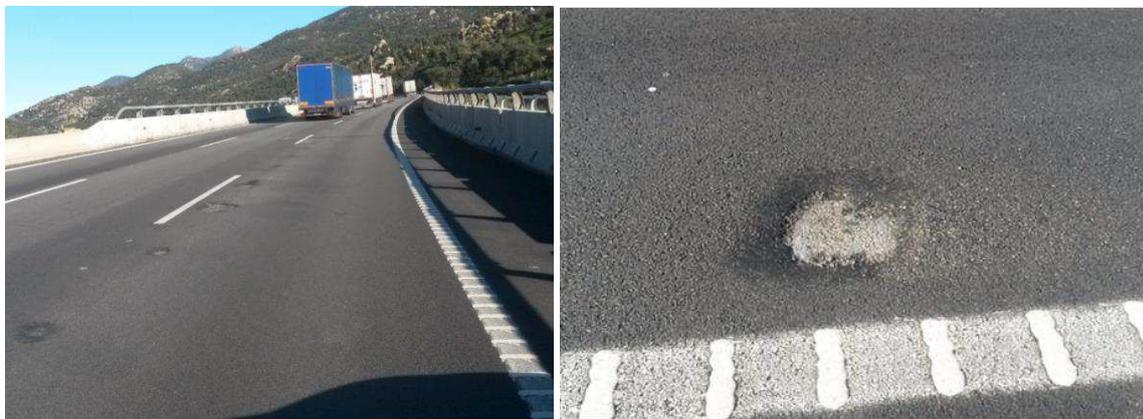
One of the major problems of asphalt pavements that are exposed to frequent oil spills is their disaggregation because oils and fuels dissolve the bitumen that acts as a binder to the mixture, leaving the aggregates loose and, therefore, susceptible to being removed under traffic and atmospheric agents action.

Figure 1 shows the affection of oil spills on the pavement. This occurs mainly in the lane for slow-moving vehicles.

**Figure 1: Examples of asphalt disaggregation due to oil spills in AP-7**

This constant deterioration of the pavement has meant considerable maintenance and reparation costs to the highway concessionaire (ACESA). For this reason, it was very convenient the study and experimentation of anti-fuel solutions to be implemented in the slow lane of AP-7.

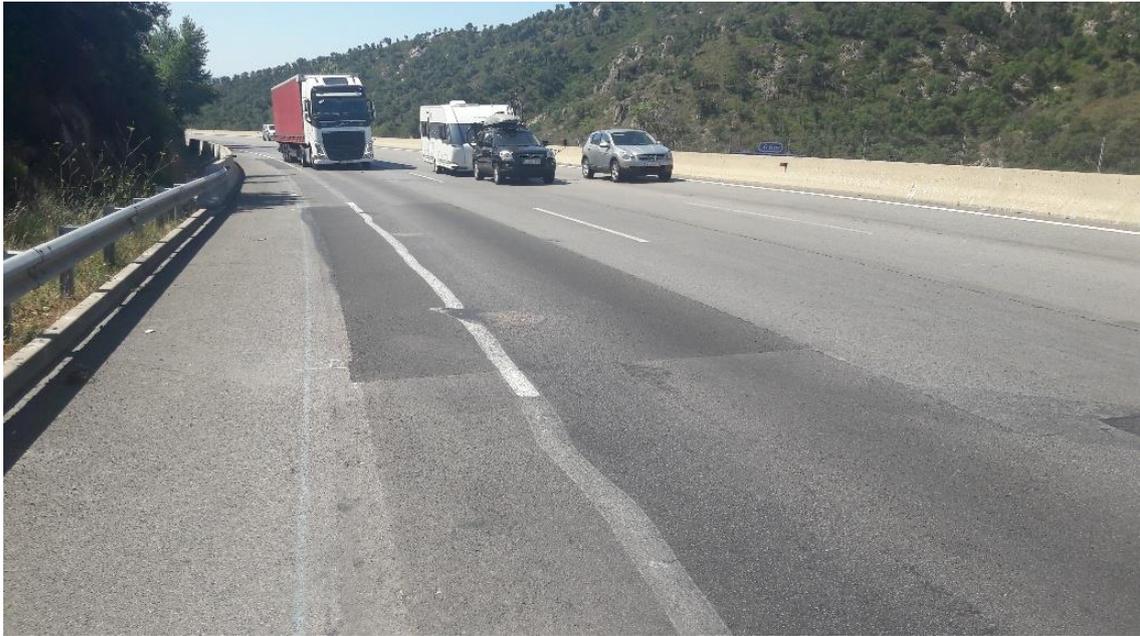
Some solutions based on fuel resistant asphalts have been developed in the last years, for example, highly modified bitumen combined with a very dense and compactable mix design or mortars based on synthetic resins applied over the surface layer. These solutions have been tested in the AP-7, but they have not been proved sufficiently effective because the durability was short and the damages due to oil leaks from the trucks soon reappeared (see Figure 2).

**Figure 2: Damage in the slow lane, after several rehabilitations**

The traditional solution for pavements subjected to frequent hydrocarbon leaks (e.g. gas stations, toll areas, airports) has been concrete pavement because it has a high resistance to fuel and chemical agents attacks. But for the concessionaire of AP-7 Highway, this kind of pavement presents some disadvantages like higher costs, difficult execution with traffic in the rest of the lanes, need of 7 days before opening to traffic, surface performances (smoothness, noise, ...). For this reason, ACESA (a company of ABERTIS Group) decided to execute a pilot section of a percolated asphalt coating as anti-fuel solution.

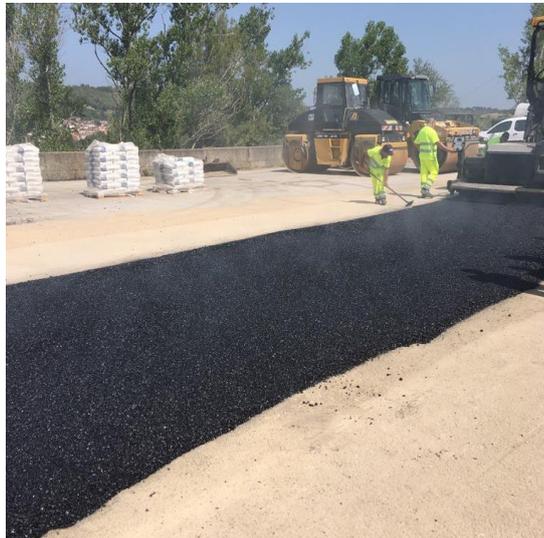
Previously, in order to validate the materials and the execution procedure to be implemented in AP-7, a series of previous studies, formulation and manufacturing tests of the mixtures and a test track were carried out in the asphalt plant. Figures 3, 4 y 5 show different moments of this preliminary trial. The percolated was done one day after the laid of the porous asphalt. The mortar selected to fabricate the cement slurry is specially designed to percolate and to achieve high short-term strength and, therefore, it would allow to open the highway traffic in 24 hours.

**Figure 3: Laying the porous asphalt in the preliminary trial**

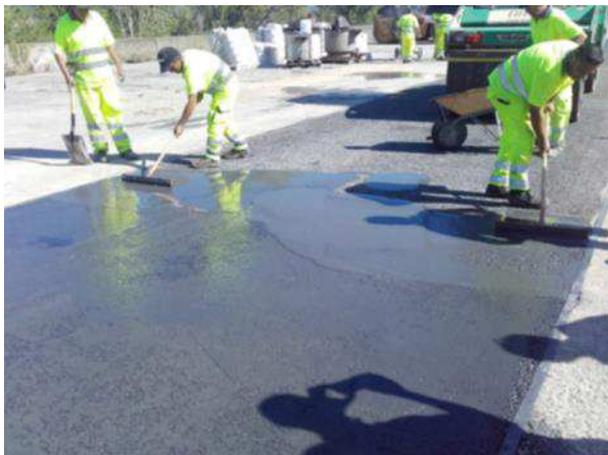
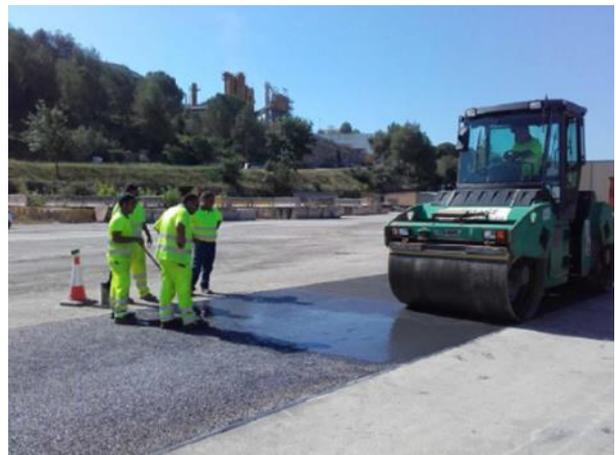
**Figure 4: Percolate of the porous asphalt in the preliminary trial**

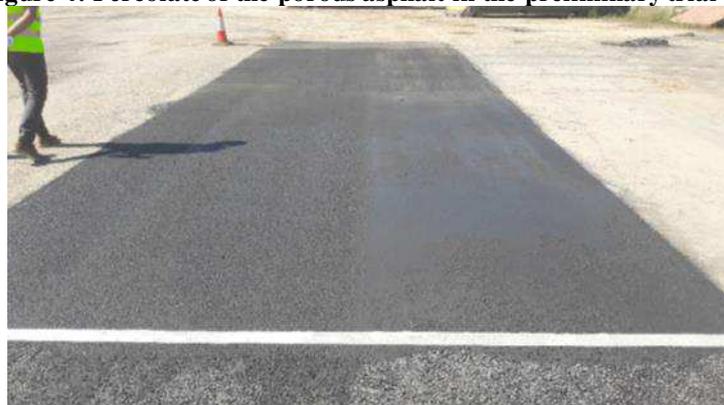
**Figure 5: Final aspect of the test section in the asphalt plant**

- The 25% void content in the porous asphalt was suitable for the percolation of the cement slurry

- To prepare the cement slurry it was needed 1 liter of water for every 4 kg of mortar
- The optimal dosage of cement slurry was determined as 3.4 l/m<sup>2</sup> of porous layer
- To obtain a correct finishing, a final brushing with mechanical sweeper with the mortar still fresh was applied
- The final color of the surface was similar to the one in the highway asphalt, so it was accepted by the client
- Samples cores were extracted to verify the whole penetration of the cement slurry. These cores were also subjected to oil immersion and resistance to hydrocarbons was confirmed

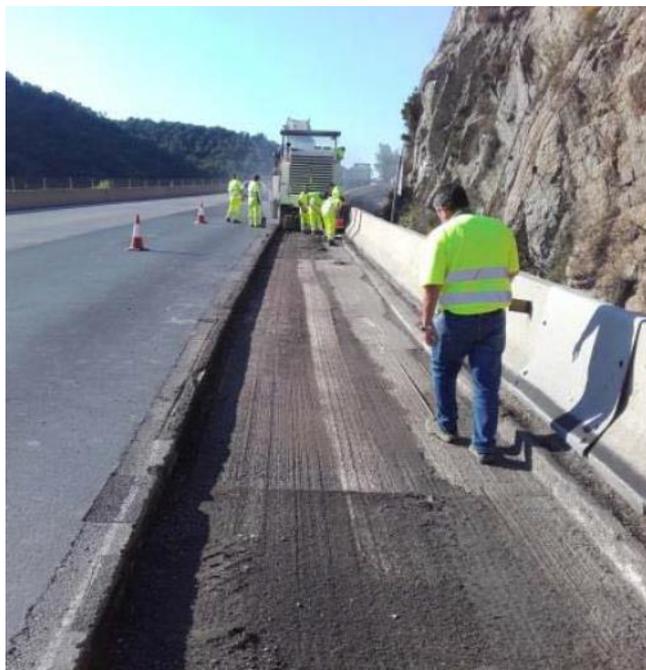
Now we go on to describe the work carried out on the AP-7. First, 14 centimetres depth of oil-contaminated pavement were removed by milling (Figure 6). This depth of milling was necessary to ensure the complete elimination of oil pollution.

Figure 6: Milling of oil-contaminated pavement

This removed pavement was replaced by two asphalt layers: a first layer, 10 cm depth, with a semi-dense asphalt concrete type AC 22 with pure bitumen 35/50 and with 20% of RAP; and a second layer (4 cm depth), with porous asphalt, PA 16, with modified bitumen PMB 45/80-65.

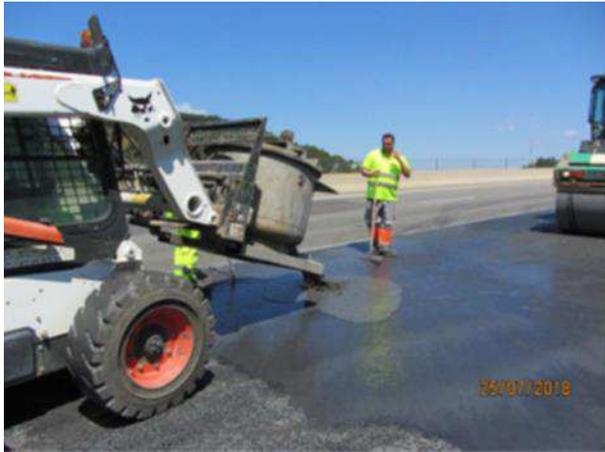
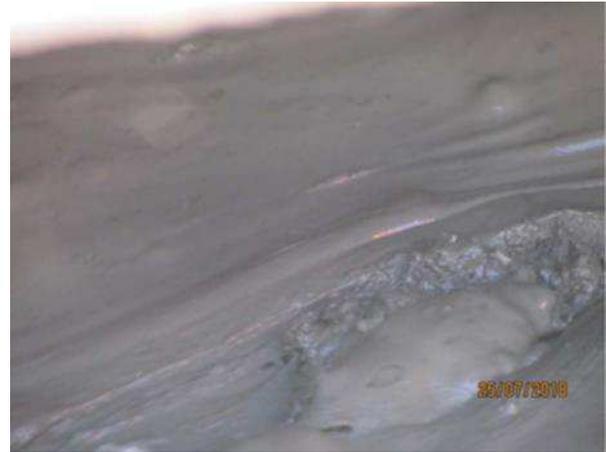
After 24 hours of the laying and compacting of the porous asphalt layer, the cement slurry was applied. The formulation and dosage of this slurry were done according to the results of the initial trial in the asphalt plant. The slurry was fabricated in a small mixer (Figure 7), transported in a forklift and poured on the pavement from the highest points, to facilitate the percolate by gravity (that is, it started from the top of the lane and worked downstream). As in the preliminary trial, after pouring the slurry, its penetration into the porous layer was aided by a tandem vibratory steel roller (Figure 8). After the roller, a brushing to remove the excess of the slurry in the surface was done and after that, a cure film was applied (Figure 9). This curing will prevent, or at least reduce, a common problem in this type of application, such as the appearance of surface fissures due to the initial retraction of any mortar with cement.

Figure 7: Left: Pouring the cement slurry. Right: Aspect of the cement slurry in the mixer

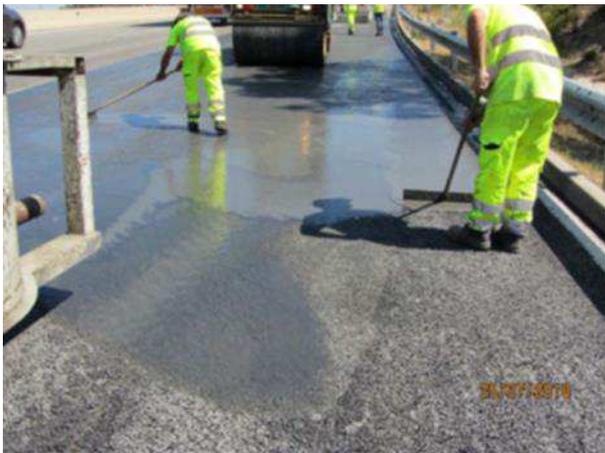
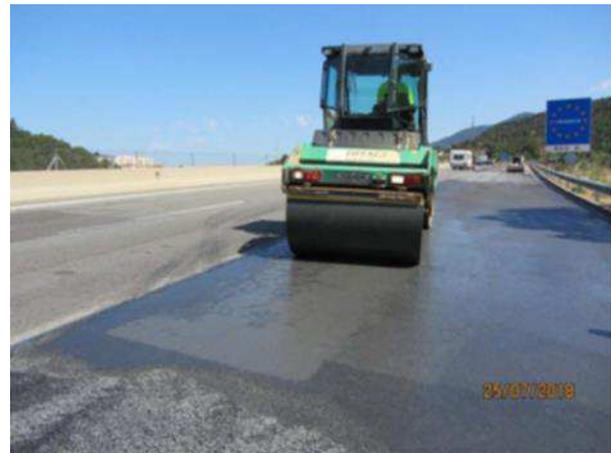
Figure 8: Percolating the slurry into the porous layer

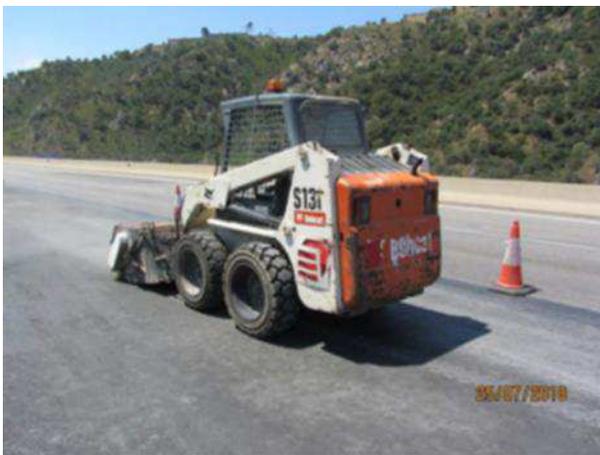
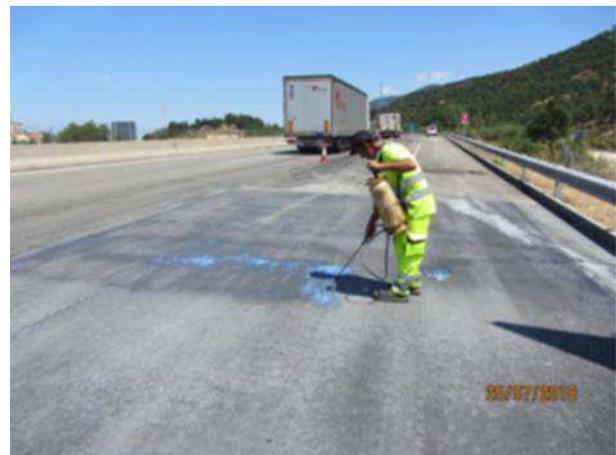
Figure 9: Finishing works: brushing and cure film application

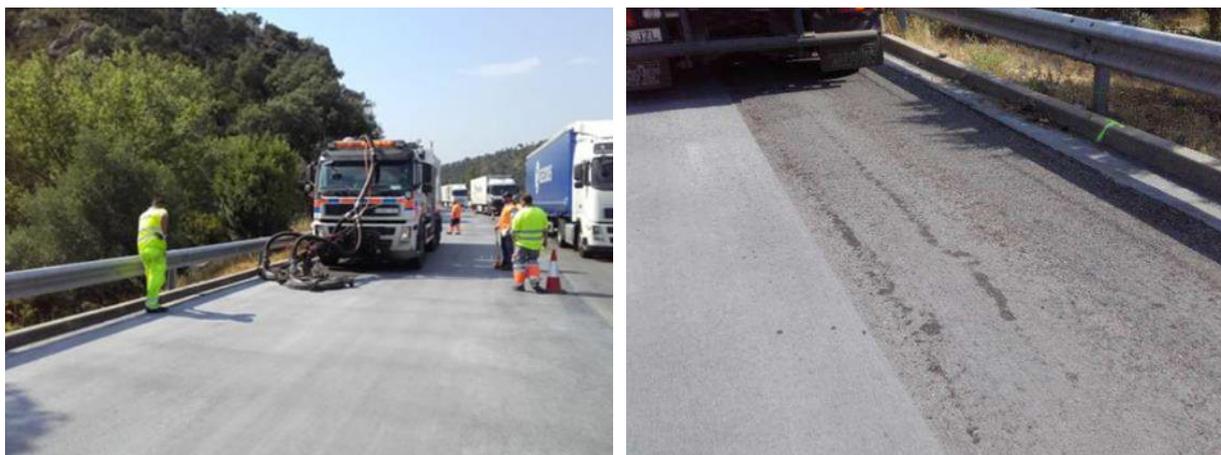
The final hydro-blasting performed in the AP-7 pilot section (Figure 10) had the following purposes:

- Removing the surface film of the slurry by applying a high-pressure flow of water
- Recover the macrotexture of the pavement
- Improving the skid resistance

**Figure 10: Left: Execution of hydro-blasting. Right: Final aspect of the surface after hydro-blasting**

Hydro-blasting is a technique that has been used on many roads throughout the Spanish territory, being able to achieve yields of between 1,500 and 2,000 m<sup>2</sup>/hour[2]. A suction system is integrated into the hydro-blasting head, so that all the water used during the jetting is absorbed and the road is only slightly wet after the passage of the equipment.

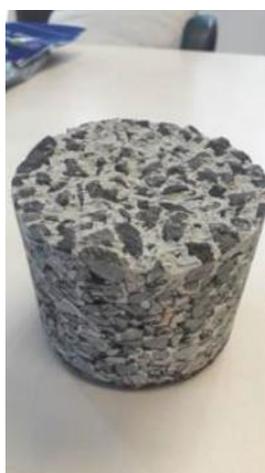
Figure 11 shows in detail the aspect of the surface after the hydro-blasting.

**Figure 11: Core extracted from the pilot section after the hydro-blasting**

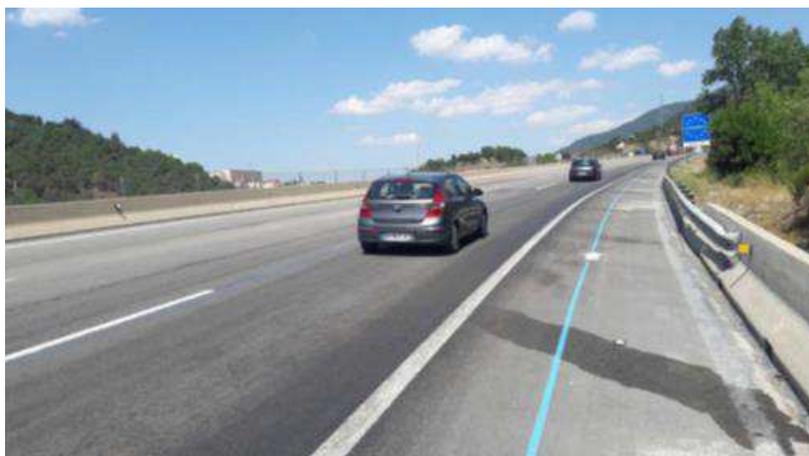
**Figure 12: 9-month old pavement status (April 2019)**

After 9 months with the new pavement under traffic (Figure 12), additional follow-up tests were monitored to evaluate the performance of the pavement. Thus, deflections were measured by falling-weight deflectometer (PRIMAX 2500 HWD) and showed that sections with percolated pavement had better structural capacity than sections with conventional asphalt (see Figure 13).

- Visual inspection after one year is completely satisfactory: there is no cracking in the surface, no disaggregation nor holes in the pavement, there have been no rutting.
- The thickness affected by gasoil never exceeds 4 mm, being normal of 1 mm.
- In terms of particle loss, the value is the same with and without oil contamination, so it can be said that the spills do not affect this feature.
- Hydro-blasting treatment as had been done in the pilot section (100 atm of water pressure) is not recommended, because there is no difference in the skid resistance after one year under traffic. To ensure a SFC greater than 55 it is estimated sufficient to apply a mechanical treatment over the percolated in the phase of curing.

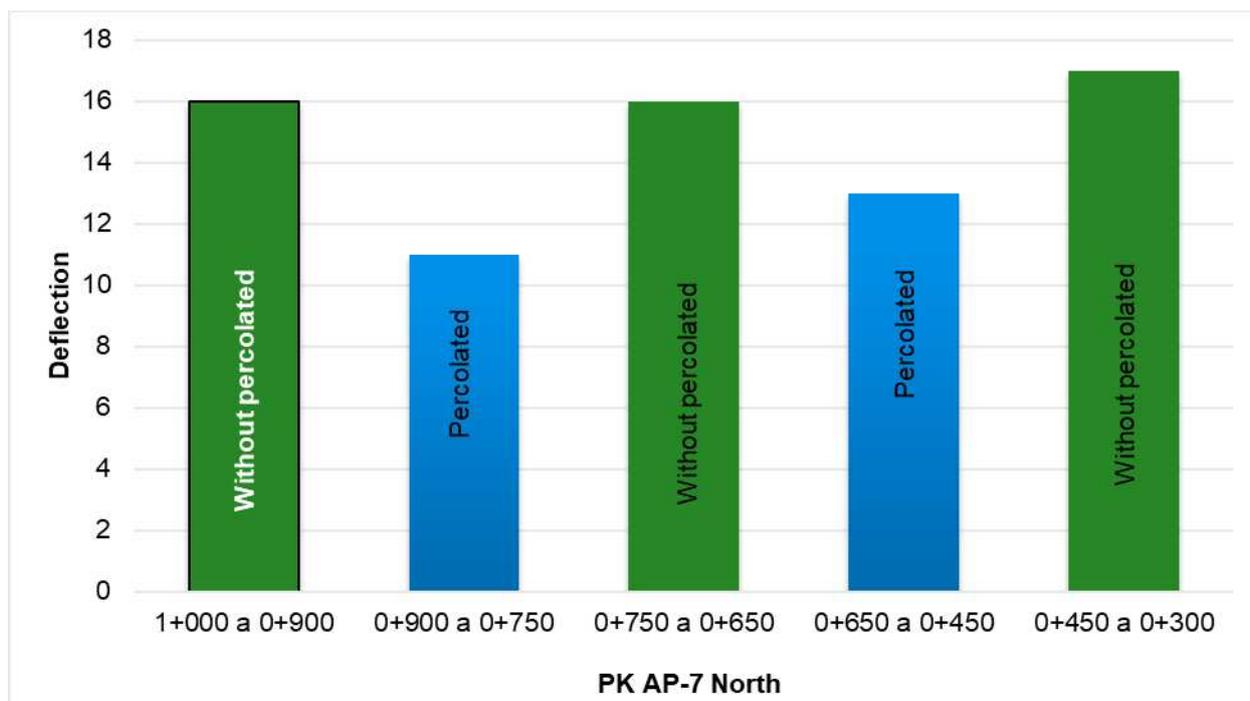
Figure 13: Comparison between sections with and without percolated (deflections)
