Asphalt mixture performance and testing

HiMA experiences in cold climate conditions

Kluttz Robert¹, Lubbers Chris¹, Kowalczyk Marek¹, Pavey Andrew²

¹Kraton Polymers, ²Alaska Department of Transportation and Public Facilities

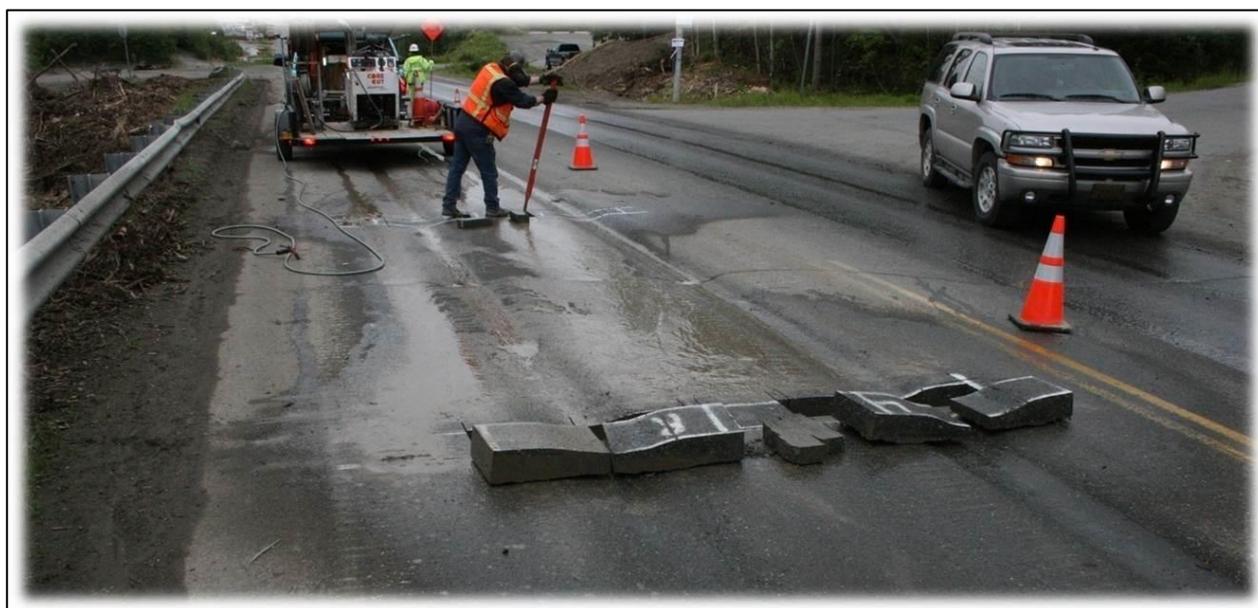
Figure 3. Resulting Abrasion Rutting

Over the years, numerous approaches have been tried to mitigate studded tire damage on asphalt pavements, which is shown in Figure 3. These methods, detailed in the previous report [2], include Stone Mastic Asphalt (SMA), pre-coated chip seal, dry process rubber modification, hard aggregates and polymer modified bitumen (PMB). None was particularly effective.

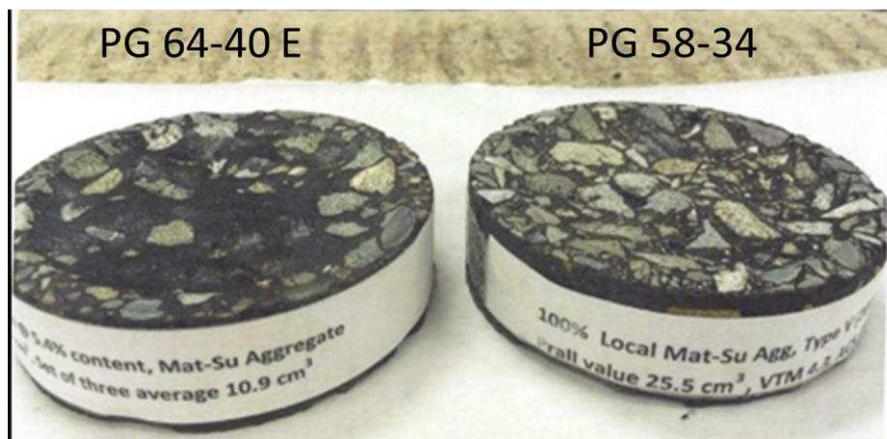
Figure 8. Abraded Prall Specimens Showing Different Damage Patterns

Comparative Prall specimens are shown in Figure 8. The standard specimen on the right shows typical abrasion with most of the aggregate clearly visible. The steel spheres progressively abrade the binder from the surface, then fracture and abrade the exposed aggregate. With the PG -40 HiMA binder, much less of the binder is abraded due to its resilience and it can continue to protect the aggregate below from fracture.

The pavement is being monitored for rutting and winter damage. It is premature for full evaluation; however the performance to date is good with no winter damage such as raveling and minimal abrasion rutting. The wheel paths look dark much like the abraded Prall test specimens indicating that roughly the same behavior is occurring in the laboratory and in the field. The Alaska DOT&PF is pleased with the performance and is specifying several more projects with PG 64-40 E binder and hard aggregates. Summer 2020, Alaska DOT&PF will conduct a detailed pavement condition evaluations on both the Anchorage project and the Glenn Highway project below which will be reported later.

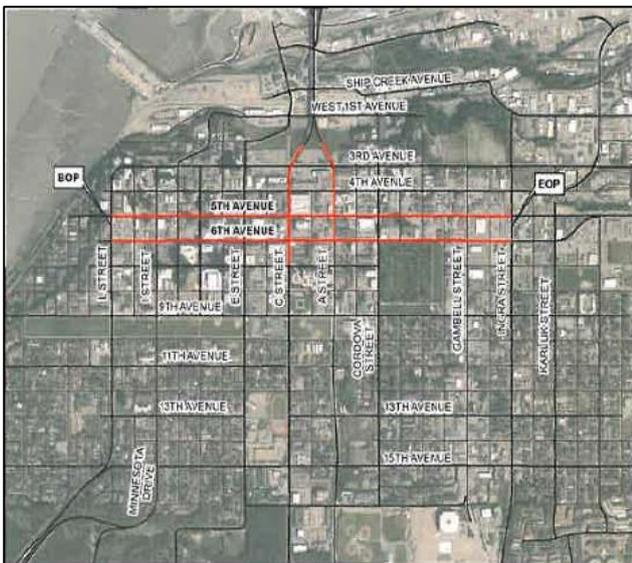
Figure 10. Downtown Anchorage

The project was a standard street resurfacing with a 44 mm mill and 50 mm fill. It comprised 5th and 6th Avenues and cross streets in downtown Anchorage. Traffic is 10,000 – 15,000 AADT. Figure 10 is a map of downtown Anchorage with the project highlighted. For reference, the project name is Anchorage 5th and 6th Avenue Resurfacing L Street to Ingra Street Project No. 59763.

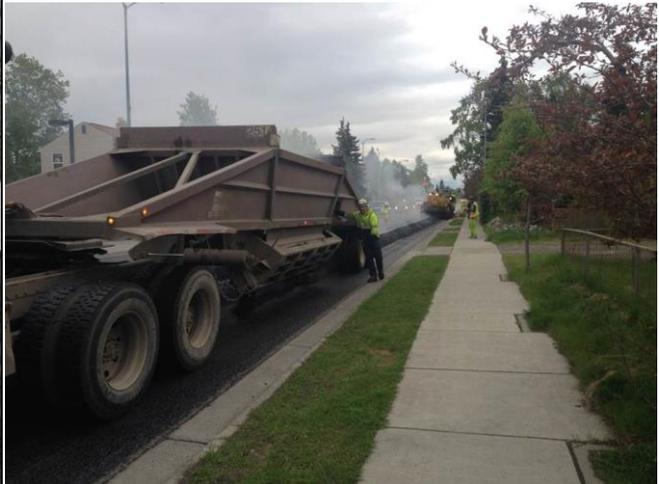
Figure 11. Windrow Paving

The PG 64E-40 binder was supplied by Denali Asphalt, LLC and the project was constructed by Granite Construction. Figure 11 shows the crowded paving conditions and windrow construction.

Construction was started in September 2014 and completed in June 2015. Paving was done at night and static rolling was required due to noise and to sensitive infrastructure. The temperature of the mat averaged 155 °C. Even with the difficult conditions and lateness in the year for the start, the contractor achieved the required mat density of 95 percent and joint density of 93 percent.

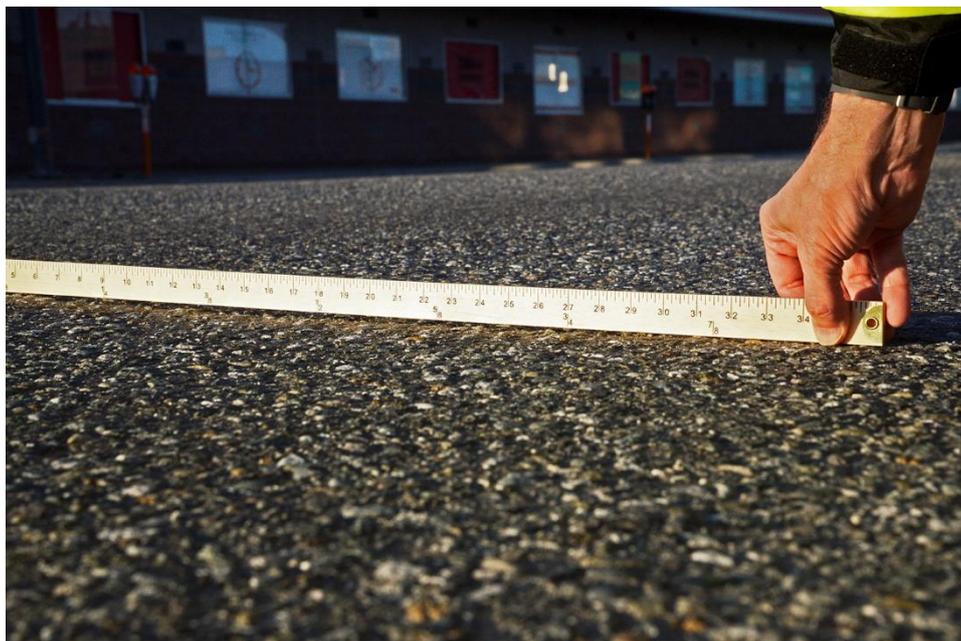
Figure 13: 200 block of E 5th Avenue – October 14, 2019

The mix placed on the Glenn Highway in 2010 incorporated crumb rubber and a PG 64-34 binder. In 2012, the average rut depth between Airport Heights and Hiland, being the most highly trafficked route in Alaska, was 8.1 mm after two winters of studded tire wear. In 2017 the rubberized mix was milled up and a Superpave mix with PG64-40 E binder and hard aggregate was placed. In 2019, the average wear on this Superpave mix between Airport Heights and Hiland was 5.3 mm after two seasons of studded tire wear. Rut depth on 6th Avenue is shown in Figure 13.

In 2015 on 5th and 6th Avenue the PG64-40 E binder was used for the first time. It was used with a Superpave mix that incorporated hard aggregate (Nordic max of 8%). In 2019, after four seasons of studded tire wear, the average rut depth on 5th Avenue is 5.2 mm, and on 6th Avenue is 5.0 mm between L Street and Ingra in downtown Anchorage.
