Asphalt reinforcement interlayers as reflective cracking mitigation system in rehabilitated pavements

Fabiana Leite-Gembus¹, Andreas Elsing¹, Patricia Amo²

¹Huesker Synthetic GmbH Germany, ²HUESKER Geosintéticos S.A. Spain

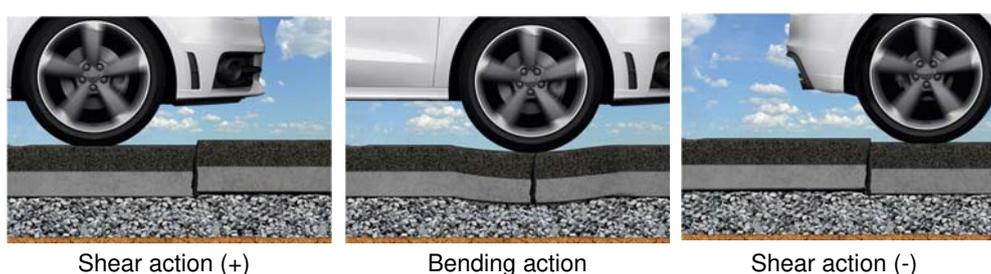
Figure 1: Critical loading cases in a pavement crack

When a wheel load passes over the road construction, localized bending and shear stresses appear on the existing crack and cause the origin and further development of cracks [3, 6]. The shear action occurs twice by each load application, while the bending action occurs only once (Figure 1).

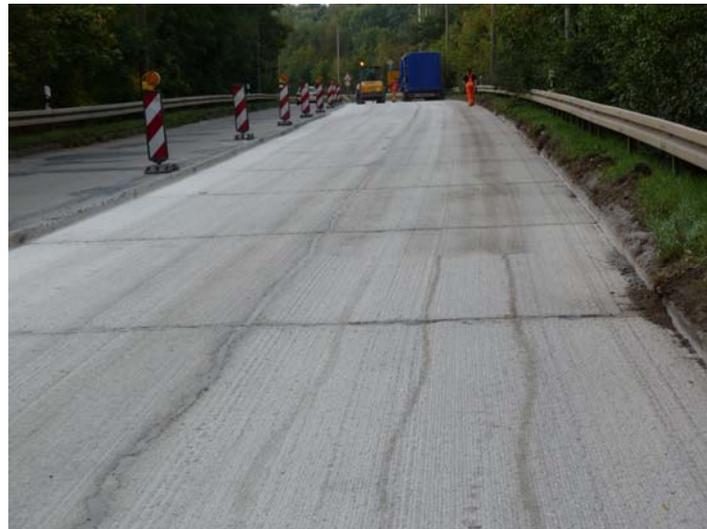
Figure 4: Milled concrete surface and filled joints

The planned rehabilitation initially required the existing 120 mm asphalt overlay to be milled off so as to expose the original concrete pavement. The concrete base was then cleaned and a crack filler was used to seal the open concrete joints (Figure 4).

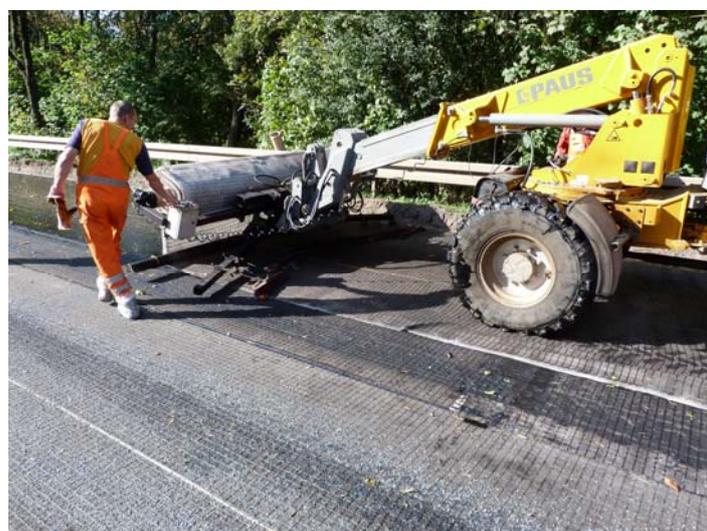
Figure 5: Installation of asphalt reinforcing composite SamiGrid

To effectively retard the future propagation of expansion joints into the new asphalt overlay, an asphalt interlayer was used. The chosen material was an asphalt reinforcing composite comprising a biaxial geogrid made from high-modulus polyvinyl alcohol (PVA) in combination with a 130 g/m² polypropylene (PP) nonwoven fabric. Unlike other raw materials, PVA offers very high resistance to alkaline environments, making it ideal for concrete pavement rehabilitation with asphalt overlays. Both the reinforcement grid and the nonwoven have a bituminous coating which contributes to a high bond between the layers and the reinforcement. The reinforcing action of the grid is complemented by the stress relief and sealing function of the bitumen saturated nonwoven.

A bitumen emulsion with 70% bitumen content was first sprayed onto the milled concrete base at a rate of approx. 2 kg/m². The asphalt reinforcing composite was then installed in accordance with the manufacturer's guidelines (Figure 5). Once in place, the asphalt interlayer was overlaid with an 80 mm binder course (AC 16 BS) and a 40 mm asphalt surface course (SMA 11 S).

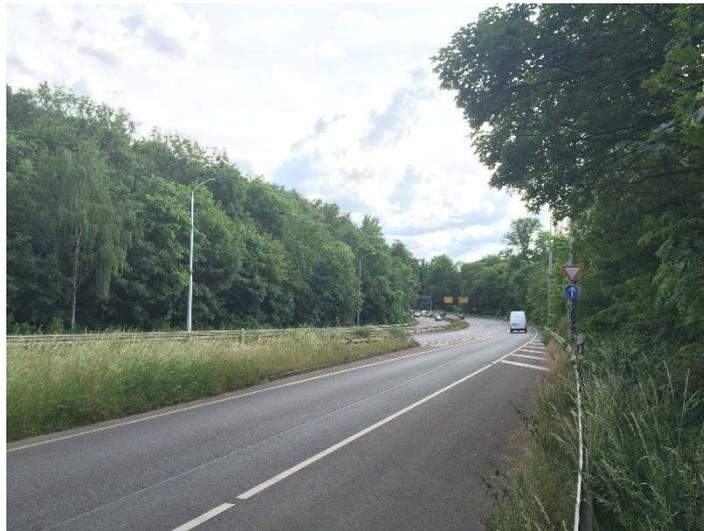
Figure 6: Pavement condition in 2016

Five years after the rehabilitation, the reinforced area in the Wundtstrasse still does not show any indication of cracking (Figure 6).

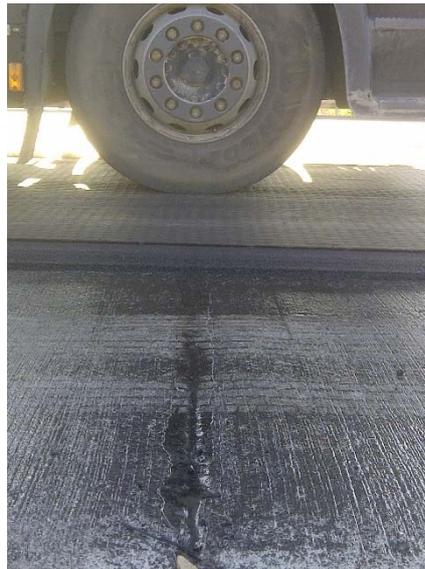
Figure 7: Detail of the sealed concrete pavement joint, asphalt regulating layer and PVA asphalt reinforcing grid with ultra-light nonwoven

The specification of geosynthetic reinforcement for asphalt application was intended to mitigate joint reflection cracking from the concrete slabs. The chosen reinforcement material is made from polyvinyl alcohol (PVA) yarns, presenting very high tensile stiffness coupled with low creep and high resistance in alkaline environments (e.g. concrete surfaces). Moreover, the product used present a polymer modified bituminous coating to enable a good bond between the asphalt layers.

rehabilitation was carried out in June 2013. Figure 7 and 8 illustrate the installation of the asphalt reinforcement interlayer.

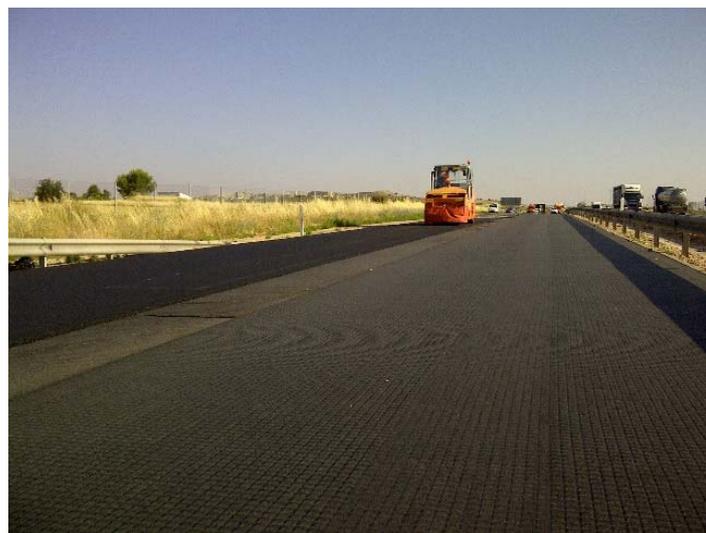
Figure 8: Rehabilitation of the Spanish Motorway A-4

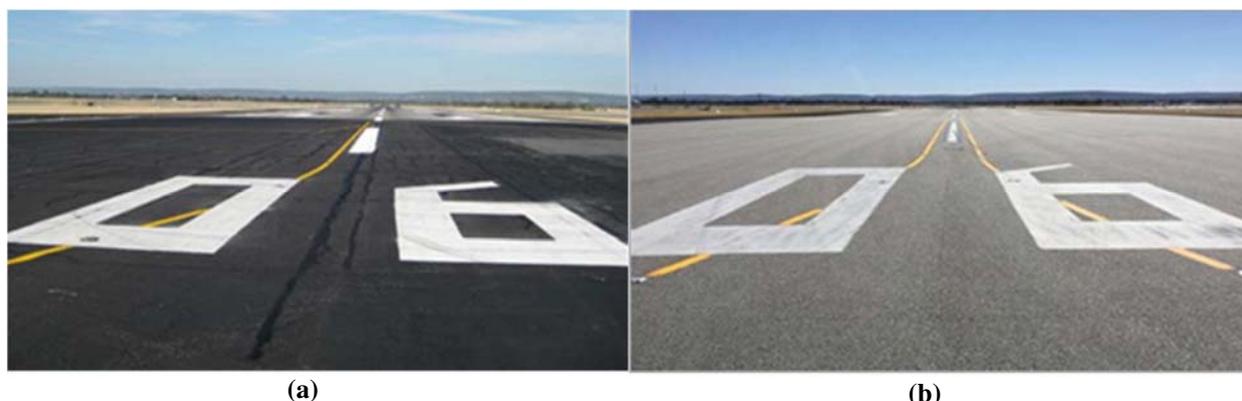
Figure 10: Pavement condition in 2009 prior to rehabilitation (a) and 8 years after rehabilitation (b)

In 2017, approximately 8 years after the rehabilitation, the condition of the Runway 06 was checked during a visual inspection (Figure 10a-b). The pavement was found to be in an extremely good condition, without the propagation of the existing cracks and joints, well exceeding the expectations. Airport authorities have confirmed the asphalt reinforcement solution to be highly successful in rehabilitation of what was once known as a very challenging runway pavement.
