**Reinforced anti-crack complex for protection of fatigued pavements:
feedback from a new preservation solution**

COLAS

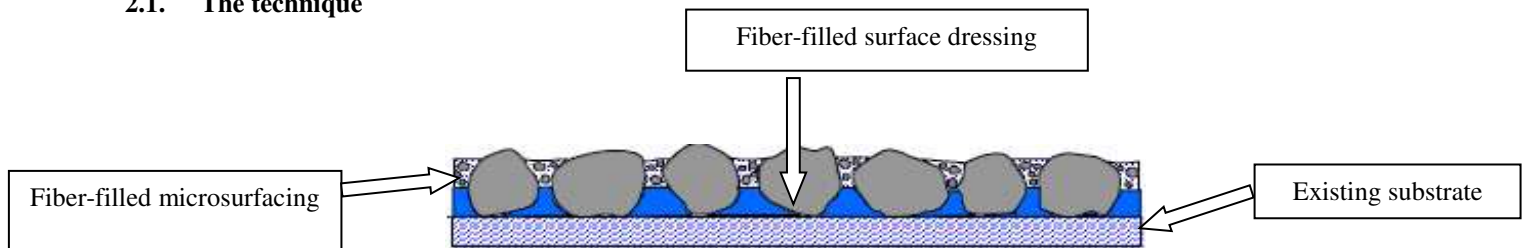
Figure 1: Cross-section showing the technique

- A first layer of fiber-filled surface dressing with a fairly sparse application of 6/10 chippings in order to ensure even distribution of the microsurfacing between the aggregate particles (sealing action).
- A second layer consisting of microsurfacing which is also fiber-filled (occasionally bituminous slurry may be used).
- Elastomer-modified emulsions are used to ensure high deformability of the composite.
- The technique can be modified according to the level of damage to the substrate and the traffic level.

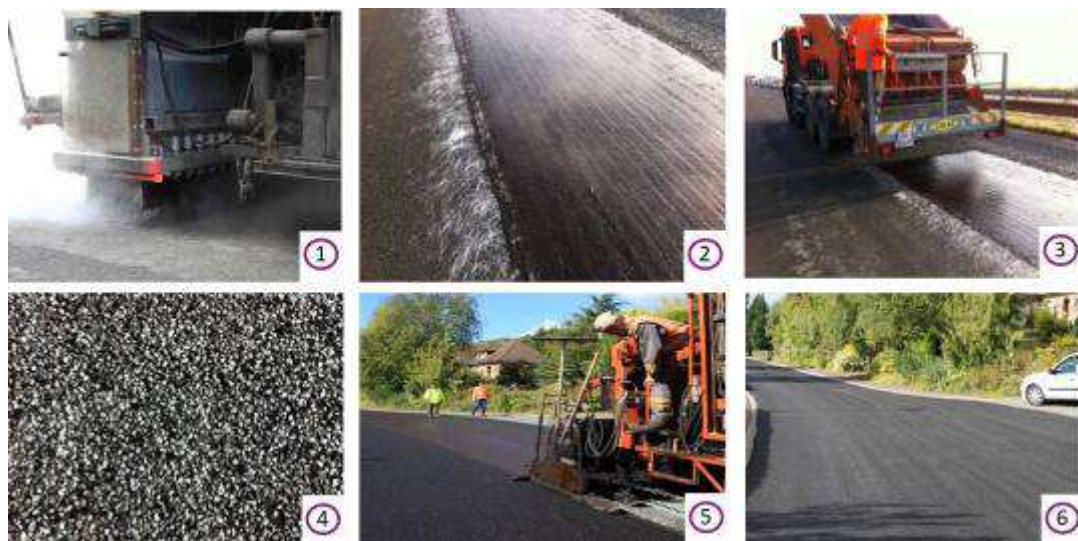
Fig. 2: Laying operations

Photo 1 & 2: Laying of emulsion + fibers

Photo 3 & 4: Laying of sparsely chipped surface dressing

Photo 5: Laying of the fiber-filled single surface dressing

Photo 6: The finished works
